**Flood Control Project Maintenance  
Levee Inspections**  
**LMA District Cover Sheet**  
**Spring 2017 Levee Inspection Results**

**Reclamation District No. 0999 Netherlands**

**Spring 2017 Levee Inspection Results**

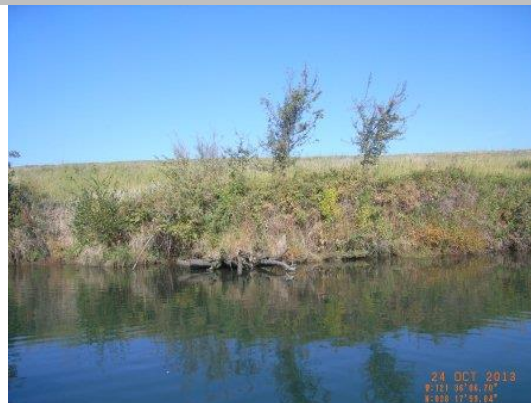
Photo 1 of 1 : SP\_2017\_RD0999\_234\_30\_20170314\_00025.jpg

LM Start	0.97	Rating **	M	Issue No.	30
LM End	1.10	Issue Type +	Ma	Location *	WS
Category	Supplemental			GPS Latitude/Longitude	
				Start	End
Item	2015 USACE Erosion Survey, DRAFT			38.299402 °	38.300542 °
				-121.603056 °	-121.601118 °
DWR ID	DWR_RD0999_03_s_2016_30				
Comment Code					
Inspector Comment					
2008 - Over steepened levee section. 2009 - Significant new erosion. 2010 - Minor new erosion. 2015: No observed changes. [2015 Site ID: STR_25-2_R]

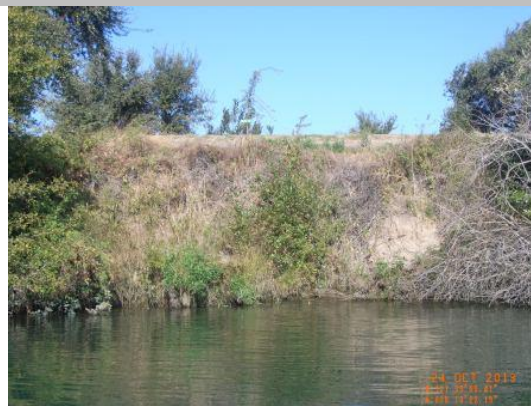
Photo 1 of 1 : SP\_2017\_RD0999\_234\_1\_20170314\_00001.jpg

LM Start	1.43	Rating **	M	Issue No.	1
LM End	1.58	Issue Type +	Ma	Location *	WS
Category	Supplemental			GPS Latitude/Longitude	
				Start	End
Item	2015 USACE Erosion Survey, DRAFT			38.305229 °	38.306667 °
				-121.599933 °	-121.598266 °
DWR ID	DWR_RD0999_03_s_2016_1				
Comment Code					
Inspector Comment					
2011 - Toe scour along length of site and erosion pockets. 2012 - Site extended slightly upstream due to new erosion pocket. 2013 - Tall vertical sections at upstream end of site. 2015: No observed changes. [2015 Site ID: STR_25-7_R]

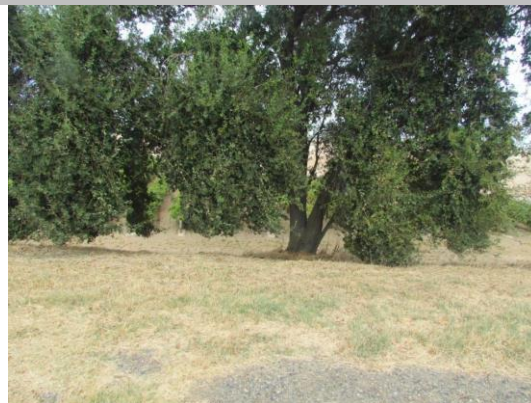
Photo 1 of 2 : SP\_2017\_RD0999\_234\_11\_20170314\_00011.jpg

LM Start	1.50	Rating **	M	Issue No.	11
LM End	1.50	Issue Type +	Ma	Location *	LS
Category	Earthen Levee			GPS Latitude/Longitude	
				Start	End
Item	Trim / Thin Trees			38.306062 °	38.306062 °
				-121.599495 °	-121.599495 °
DWR ID	DWR_RD0999_03_s_2012_11				
Comment Code					
T1 : Trim trees to at least five feet above ground level.					
Inspector Comment

Looking at untrimmed trees on landward slope and toe. (Fall 2016)

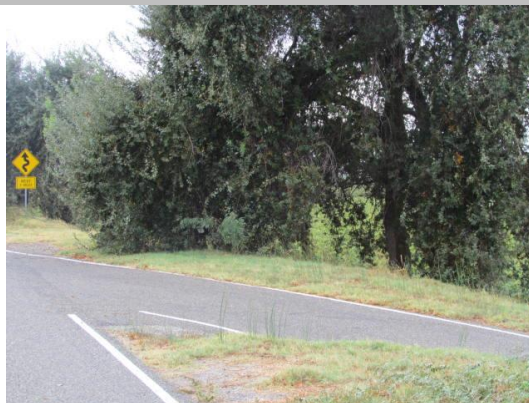
Photo 2 of 2 : SP\_2017\_RD0999\_234\_11\_20170314\_00012.jpg

LM Start	1.50	Rating **	M	Issue No.	11 (cont)	
LM End	1.50	Issue Type +	Ma	Location *	LS	
Category	Earthen Levee			GPS Latitude/Longitude		
				Start		End
Item	Trim / Thin Trees			38.306062 °		38.306062 °
				-121.599495 °		-121.599495 °
DWR ID	DWR_RD0999_03_s_2012_11					
Comment Code						
T1 : Trim trees to at least five feet above ground level.						
Inspector Comment

Looking at untrimmed trees on landward slope and toe. (Spring 2016)

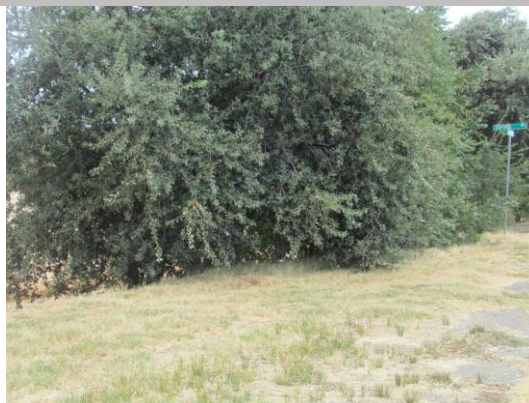
Photo 1 of 1 : SP\_2017\_RD0999\_234\_12\_20170314\_00013.jpg

LM Start	1.53	Rating **	U	Issue No.	12
LM End	1.53	Issue Type +	Ma	Location *	LS
Category	Earthen Levee			GPS Latitude/Longitude	
				Start	End
Item	Trim / Thin Trees			38.306332 °	38.306332 °
				-121.599109 °	-121.599109 °
DWR ID	DWR_RD0999_03_s_2012_12				
Comment Code					
T1 : Trim trees to at least five feet above ground level.					
Inspector Comment

Looking east at untrimmed trees on landward slope.

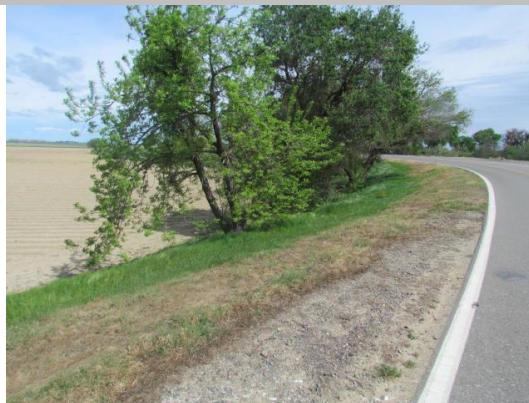
Photo 1 of 1 : SP\_2017\_RD0999\_234\_13\_20170314\_00014.jpg

LM Start	1.57	Rating **	M	Issue No.	13
LM End	1.59	Issue Type +	Ma	Location *	LS
Category	Earthen Levee			GPS Latitude/Longitude	
				Start	End
Item	Trim / Thin Trees			38.306762 °	38.306948 °
				-121.598541 °	-121.598320 °
DWR ID	DWR_RD0999_03_s_2012_13				
Comment Code					
T3 : Trim and thin trees to allow visibility of the ground and room to flood fight.					
Inspector Comment

Looking north at untrimmed trees on landward toe. (Spring 2015)

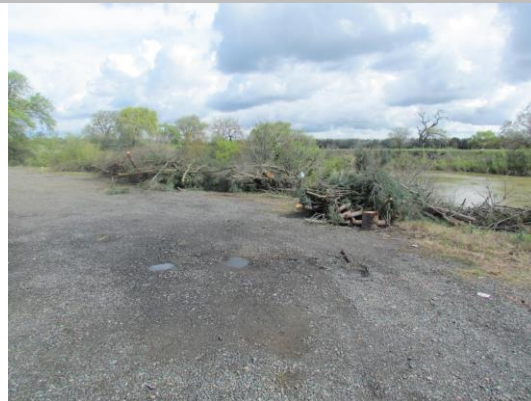
Photo 1 of 1 : SP\_2017\_RD0999\_234\_25\_20170324\_00045.jpg

LM Start	1.61	Rating **	U	Issue No.	25
LM End	1.61	Issue Type +	Ma	Location *	WS
Category	Earthen Levee			GPS Latitude/Longitude	
				Start	End
Item	Encroachments			38.307295 °	38.307295 °
				-121.598202 °	-121.598202 °
DWR ID	DWR_RD0999_03_s_2017_25				
Comment Code					
PR : Prunings					
Inspector Comment

Looking east at several large pruning piles on waterward slope.

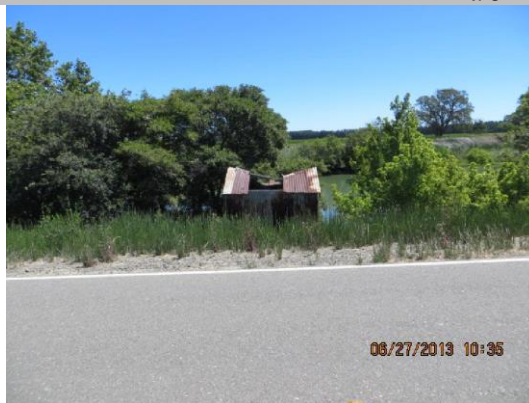
Photo 1 of 3 : UCIP\_SP\_2017\_15392\_25261.jpg

LM Start	1.71	Rating **	M	Issue No.	52
LM End	1.71	Issue Type +	En	Location *	LS
Category	Supplemental			GPS Latitude/Longitude	
				Start	End
Item	DWR UCIP Field Study			38.308513 °	38.308513 °
				-121.598874 °	-121.598874 °
DWR ID					
Comment Code					
Inspector Comment					
FS_ID:15392 DS_ID:22779 EP_NO: N/A Repair Type: Non-Urgent Crossing Status: Found UCIP Comments: Pipe abandoned and should be verified as being done so properly. FIELD_STRUCT_DESC: *Abandoned* 5-inch pipe through levee 4.4 feet below crown. Pump and valve in pump house on the waterward slope (couldn't see landward end of pipe 2/91). 1-inch galvanized iron electric conduit at same location. Originally included in the 1966 O&M manual. FS Date: 6/27/2013

Pumphouse visible on WS slope.

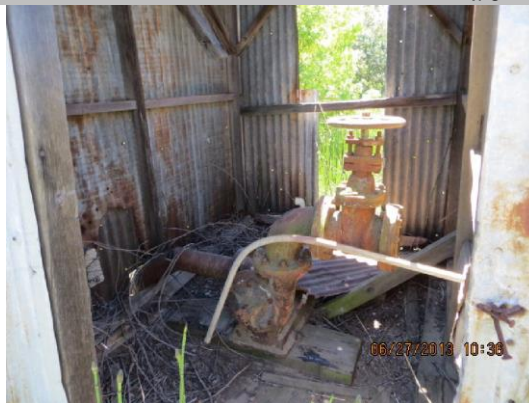
Photo 3 of 3 : UCIP\_SP\_2017\_15392\_25259.jpg

LM Start	1.71	Rating **	M	Issue No.	52 (cont)	
LM End	1.71	Issue Type +	En	Location *	LS	
Category	Supplemental			GPS Latitude/Longitude		
				Start	End	
Item	DWR UCIP Field Study			38.308513 °	38.308513 °	
				-121.598874 °	-121.598874 °	
DWR ID						
Comment Code						
Inspector Comment						
FS_ID:15392 DS_ID:22779 EP_NO: N/A Repair Type: Non-Urgent Crossing Status: Found UCIP Comments: Pipe abandoned and should be verified as being done so properly. FIELD_STRUCT_DESC: *Abandoned* 5-inch pipe through levee 4.4 feet below crown. Pump and valve in pump house on the waterward slope (couldn't see landward end of pipe 2/91). 1-inch galvanized iron electric conduit at same location. Originally included in the 1966 O&M manual. FS Date: 6/27/2013

gatevalve inside pumphouse with no connection.

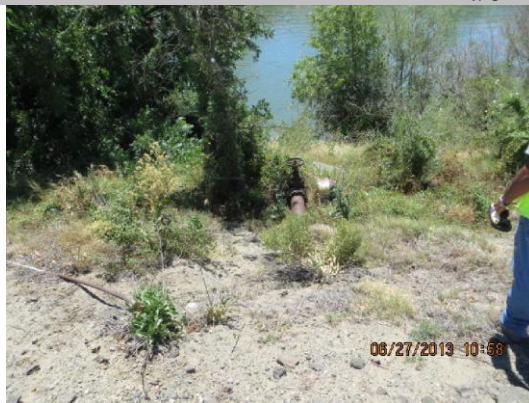
Photo 1 of 3 : UCIP\_SP\_2017\_15393\_25264.jpg

LM Start	2.00	Rating **	M	Issue No.	53
LM End	2.00	Issue Type +	En	Location *	LS
Category	Supplemental			GPS Latitude/Longitude	
				Start	End
Item	DWR UCIP Field Study			38.311709 °	38.311709 °
				-121.596713 °	-121.596713 °
DWR ID					
Comment Code					
Inspector Comment					
FS_ID:15393					
DS_ID:22780					
EP_NO: N/A					
Repair Type: Non-Urgent					
Crossing Status: Found					
UCIP Comments: Pipe abandoned and should be done so properly.					
FIELD_STRUCT_DESC: 7-inch pipe through levee 4.6 feet below crown. Pump and gate valve on waterward slope. Service pole on the landward slope. 1-inch galvanized iron electrical conduit at same location. Originally included in the 1966 O&M manual.					
FS Date: 6/27/2013

Pipe visible on WS slope.

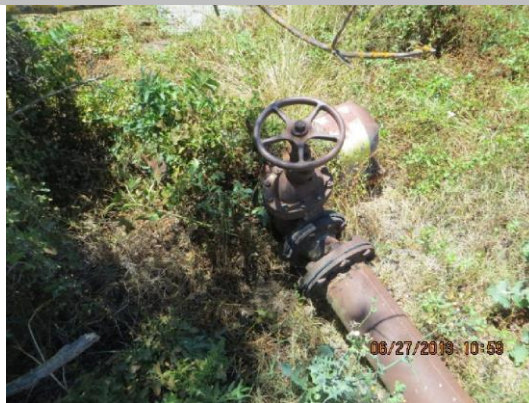
Photo 2 of 3 : UCIP\_SP\_2017\_15393\_25263.jpg

Gate valve on WS slope at pump.

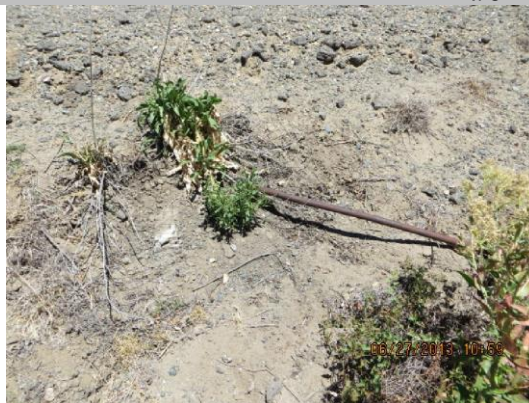
Photo 3 of 3 : UCIP\_SP\_2017\_15393\_25262.jpg

LM Start	2.00	Rating **	M	Issue No.	53 (cont)	
LM End	2.00	Issue Type +	En	Location *	LS	
Category	Supplemental			GPS Latitude/Longitude		
				Start	End	
Item	DWR UCIP Field Study			38.311709 °	38.311709 °	
				-121.596713 °	-121.596713 °	
DWR ID						
Comment Code						
Inspector Comment						
FS_ID:15393						
DS_ID:22780						
EP_NO: N/A						
Repair Type: Non-Urgent						
Crossing Status: Found						
UCIP Comments: Pipe abandoned and should be done so properly.						
FIELD_STRUCT_DESC: 7-inch pipe through levee 4.6 feet below crown. Pump and gate valve on waterward slope. Service pole on the landward slope. 1-inch galvanized iron electrical conduit at same location. Originally included in the 1966 O&M manual.						
FS Date: 6/27/2013

Galvanized iron pipe on WS slope.

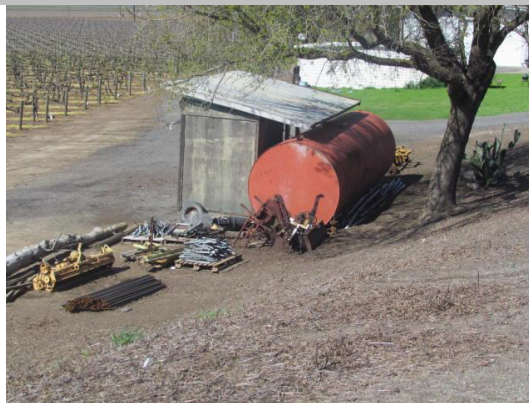
Photo 1 of 3 : SP\_2017\_RD0999\_234\_27\_20170314\_00021.jpg

LM Start	2.54	Rating **	U	Issue No.	27
LM End	2.54	Issue Type +	En	Location *	LS
Category	Earthen Levee			GPS Latitude/Longitude	
				Start	End
Item	Encroachments			38.317840 °	38.317840 °
				-121.590895 °	-121.590895 °
DWR ID	DWR_RD0999_03_s_2012_27				
Comment Code					
EQ : Equipment					
Inspector Comment					
Diesel tank stored at landside toe.

Looking northwest at diesel tank and other farm equipment stored at landward toe. (Spring 2016)

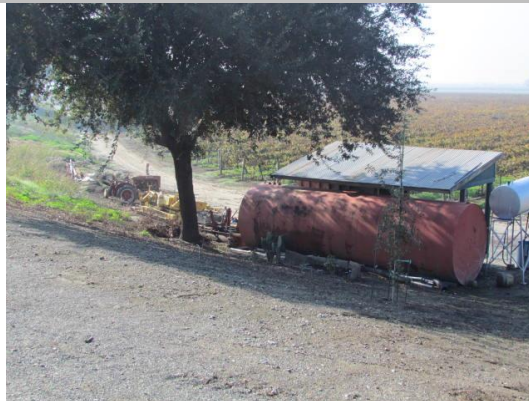
Photo 2 of 3 : SP\_2017\_RD0999\_234\_27\_20170314\_00022.jpg

LM Start	2.54	Rating **	U	Issue No.	27 (cont)	
LM End	2.54	Issue Type +	En	Location *	LS	
Category	Earthen Levee			GPS Latitude/Longitude		
				Start	End	
Item	Encroachments			38.317840 °	38.317840 °	
				-121.590895 °	-121.590895 °	
DWR ID	DWR_RD0999_03_s_2012_27					
Comment Code						
EQ : Equipment						
Inspector Comment						
Diesel tank stored at landside toe.

Looking southwest at farm equipment stored at landside toe. (Fall Inspection 2012)

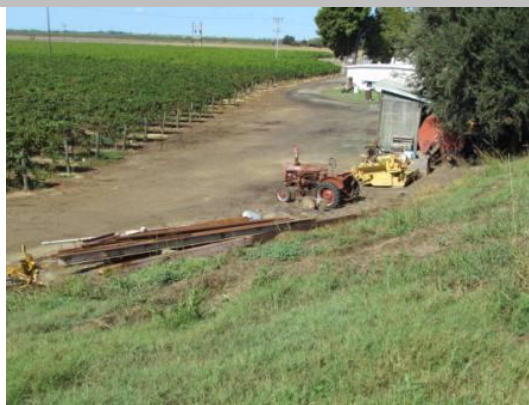
Photo 3 of 3 : SP\_2017\_RD0999\_234\_27\_20170314\_00023.jpg

Looking northwest at equipment at landside toe.

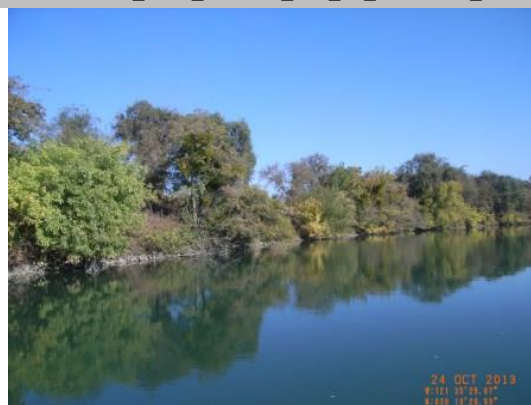
Photo 1 of 1 : SP\_2017\_RD0999\_234\_21\_20170314\_00018.jpg

LM Start	2.87	Rating **	M	Issue No.	21
LM End	2.92	Issue Type +	Ma	Location *	WS
Category	Supplemental			GPS Latitude/Longitude	
				Start	End
Item	2015 USACE Erosion Survey, DRAFT			38.322457 °	38.323042 °
				-121.590693 °	-121.590209 °
DWR ID	DWR_RD0999_03_s_2016_21				
Comment Code					
Inspector Comment					
2012 - Slumping of upper levee slope. 2015: No observed changes. [2015 Site ID: STR_27-1_R]

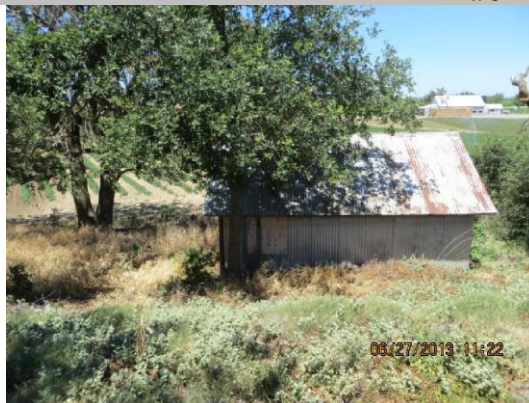
Photo 1 of 3 : UCIP\_SP\_2017\_15406\_25285.jpg

LM Start	2.88	Rating **	M	Issue No.	54
LM End	2.88	Issue Type +	En	Location *	WS
Category	Supplemental			GPS Latitude/Longitude	
				Start	End
Item	DWR UCIP Field Study			38.322652 °	38.322652 °
				-121.590841 °	-121.590841 °
DWR ID					
Comment Code					
Inspector Comment					
FS_ID:15406					
DS_ID:22782					
EP_NO: N/A					
Repair Type: Non-Urgent					
Crossing Status: Found					
UCIP Comments: This pipe is abandoned and should be done so properly.					
FIELD_STRUCT_DESC: *ABANDONED* 16-inch pipe through levee 9.3 feet below crown. Pump and gate valve in pump house on the landward slope. Originally included in the 1966 O&M manual.					
FS Date: 6/27/2013

Pumphouse on LS toe.

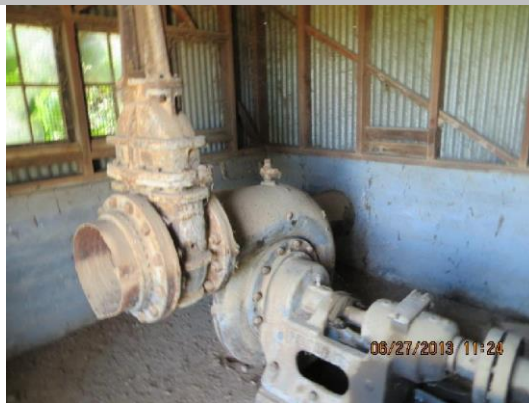
Photo 2 of 3 : UCIP\_SP\_2017\_15406\_25284.jpg

Pump and gate valve inside pumphouse at LS toe.

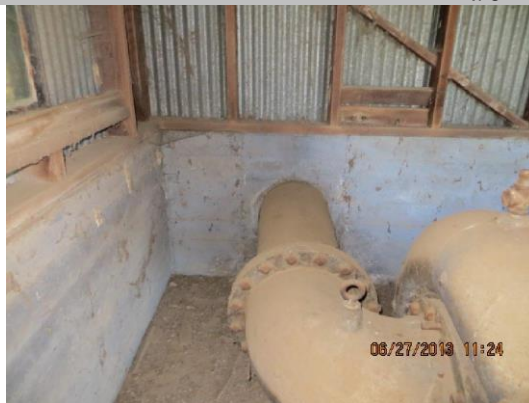
Photo 3 of 3 : UCIP\_SP\_2017\_15406\_25283.jpg

LM Start	2.88	Rating **	M	Issue No.	54 (cont)
LM End	2.88	Issue Type +	En	Location *	WS
Category	Supplemental			GPS Latitude/Longitude	
				Start	End
Item	DWR UCIP Field Study			38.322652 °	38.322652 °
				-121.590841 °	-121.590841 °
DWR ID					
Comment Code					
Inspector Comment					
FS_ID:15406 DS_ID:22782 EP_NO: N/A Repair Type: Non-Urgent Crossing Status: Found UCIP Comments: This pipe is abandoned and should be done so properly. FIELD_STRUCT_DESC: *ABANDONED* 16-inch pipe through levee 9.3 feet below crown. Pump and gate valve in pump house on the landward slope. Originally included in the 1966 O&M manual. FS Date: 6/27/2013

Pipe entering levee at LS toe.

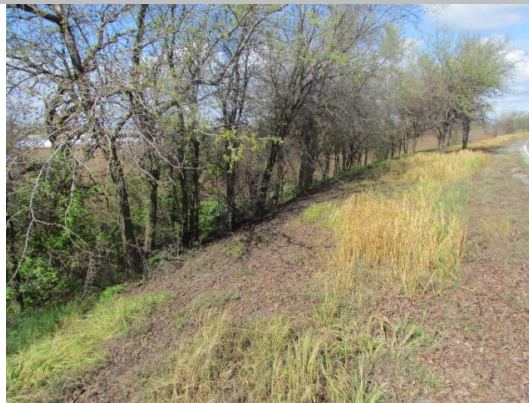
Photo 1 of 4 : SP\_2017\_RD0999\_234\_10\_20170314\_00007.jpg

LM Start	2.88	Rating **	U	Issue No.	10
LM End	2.88	Issue Type +	Ma	Location *	LS
Category	Earthen Levee			GPS Latitude/Longitude	
				Start	End
Item	Trim / Thin Trees			38.322757 °	38.322757 °
				-121.590817 °	-121.590817 °
DWR ID	DWR_RD0999_03_f_2012_10				
Comment Code					
T3 : Trim and thin trees to allow visibility of the ground and room to flood fight.					
Inspector Comment					
Wild growth at landside slope and toe.

Looking northwest at dense vegetation on landward slope and toe.  
(Spring 2016)

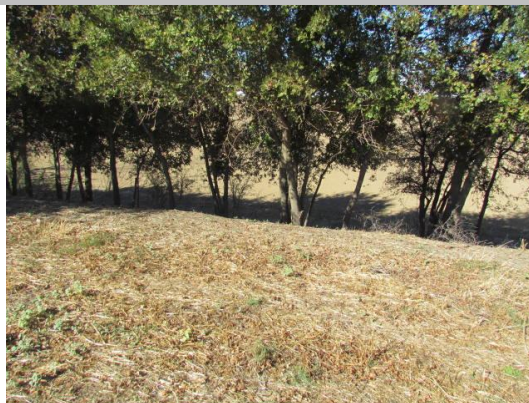
Photo 2 of 4 : SP\_2017\_RD0999\_234\_10\_20170314\_00008.jpg

Looking west at trimmed trees at landward toe. (Fall 2014)

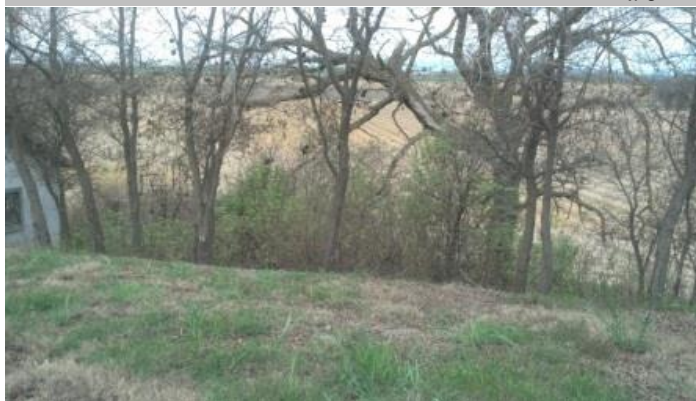
Photo 3 of 4 : SP\_2017\_RD0999\_234\_10\_20170314\_00009.jpg

Looking west at dense trees on landside toe.

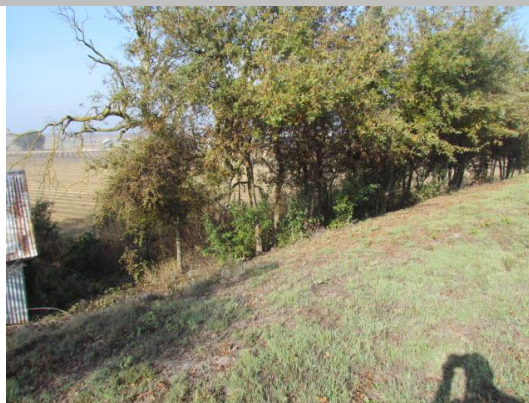
Photo 4 of 4 : SP\_2017\_RD0999\_234\_10\_20170314\_00010.jpg

Looking northwest at dense vegetation at landside slope and toe.

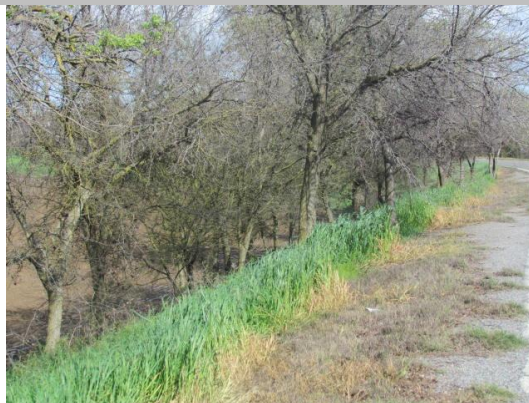
Photo 1 of 2 : SP\_2017\_RD0999\_234\_31\_20170314\_00026.jpg

LM Start	3.01	Rating **	U	Issue No.	31
LM End	3.25	Issue Type +	Ma	Location *	LS
Category	Earthen Levee			GPS Latitude/Longitude	
				Start	End
Item	Trim / Thin Trees			38.323770 °	38.326061 °
				-121.589035 °	-121.586028 °
DWR ID	DWR_RD0999_03_s_2012_31				
Comment Code					
T3 : Trim and thin trees to allow visibility of the ground and room to flood fight.					
Inspector Comment

Looking northwest at untrimmed trees on landward slope. (Spring 2016)

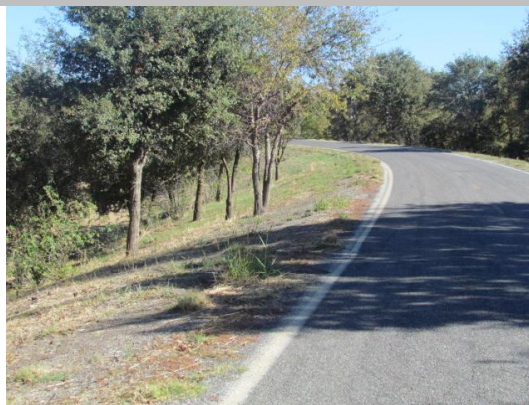
Photo 2 of 2 : SP\_2017\_RD0999\_234\_31\_20170314\_00027.jpg

Looking north at trimmed trees on landward slope.

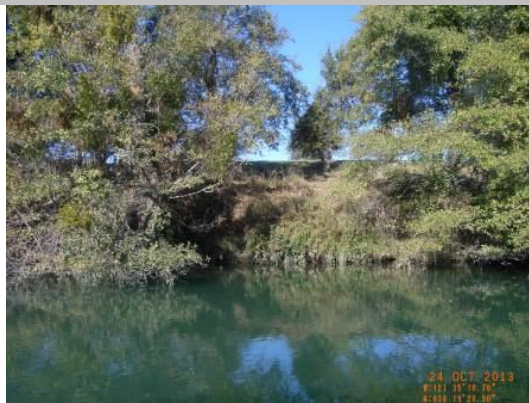
Photo 1 of 1 : SP\_2017\_RD0999\_234\_5\_20170314\_00004.jpg

LM Start	3.05	Rating **	M	Issue No.	5
LM End	3.23	Issue Type +	Ma	Location *	WS
Category	Supplemental			GPS Latitude/Longitude	
				Start	End
Item	2015 USACE Erosion Survey, DRAFT			38.323667 °	38.325592 °
				-121.588226 °	-121.585925 °
DWR ID	DWR_RD0999_03_s_2016_5				
Comment Code					
Inspector Comment					
2011 - Multiple erosion pockets. Some likely from tree popouts. 2013 - Tall vertical sections. 2015: New tree popout and significant new erosion. [2015 Site ID: STR_27-3_R]

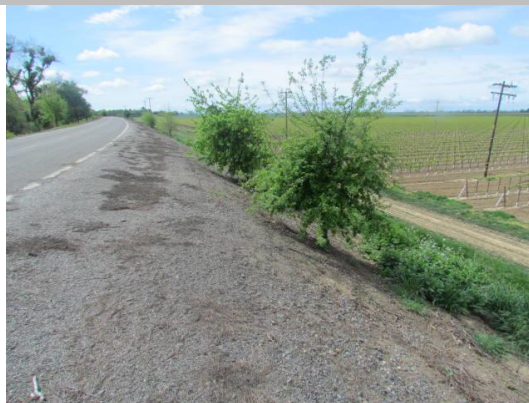
Photo 1 of 1 : SP\_2017\_RD0999\_234\_44\_20170314\_00029.jpg

LM Start	3.60	Rating **	M	Issue No.	44
LM End	3.64	Issue Type +	Ma	Location *	LS
Category	Earthen Levee			GPS Latitude/Longitude	
				Start	End
Item	Trim / Thin Trees			38.330946 °	38.331415 °
				-121.585932 °	-121.585534 °
DWR ID	DWR_RD0999_03_s_2015_44				
Comment Code					
T2 : Thin trees to allow visibility of the ground and room to flood fight.					
Inspector Comment					
Remove trees less than four inches in diameter at chest height. Don't allow young trees to get establish on levee slope.

Looking southwest at typical view of young oak trees on landward slope. (Spring 2015)

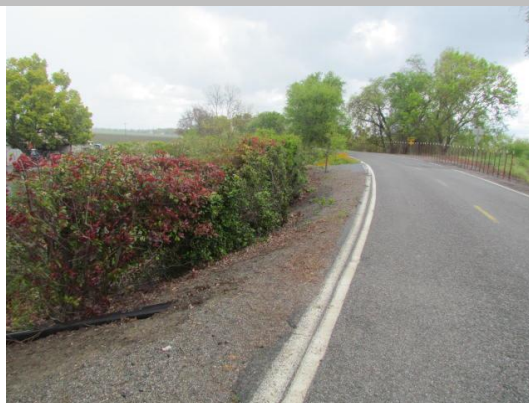
Photo 1 of 2 : SP\_2017\_RD0999\_234\_22\_20170314\_00019.jpg

LM Start	3.70	Rating **	U	Issue No.	22
LM End	3.71	Issue Type +	En	Location *	LS
Category	Earthen Levee			GPS Latitude/Longitude	
				Start	End
Item	Vegetation			38.332017 °	38.332156 °
				-121.584807 °	-121.584707 °
DWR ID	DWR_RD0999_03_s_2012_22				
Comment Code					
V6 : Landscaping					
Inspector Comment

Looking southwest at trimmed landscaping on landside slope, but still blocking levee slope.

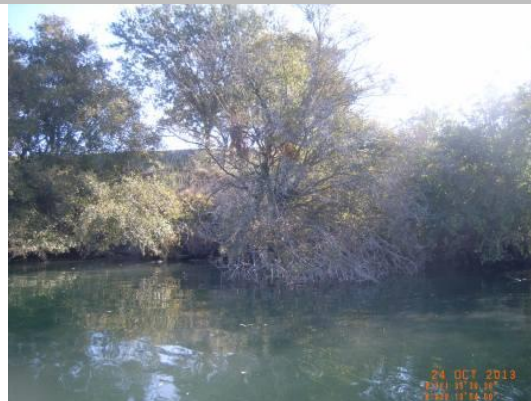
Photo 1 of 1 : SP\_2017\_RD0999\_234\_18\_20170314\_00017.jpg

LM Start	4.56	Rating **	M	Issue No.	18
LM End	4.68	Issue Type +	Ma	Location *	WS
Category	Supplemental			GPS Latitude/Longitude	
				Start	End
Item	2015 USACE Erosion Survey, DRAFT			38.313836 °	38.315407 °
				-121.592259 °	-121.591433 °
DWR ID	DWR_RD0999_03_s_2016_18				
Comment Code					
Inspector Comment					
2002 - Original rock over geotextile is sliding off and the end is coming unraveled. 2003 - Some minor new erosion on the downstream end. 2004 - Site has gotten worse. Underlined geofabric is exposed. 2005 - Still looks bad with exposed geotextile fabric. 2006 - Still have some new unraveling and exposed fabric. Site lengthened upstream. 2009 - Minimal new erosion. 2010 - geotextile fabric placed since last year, possible flood fight. 2012 - Exposed geotech style fabric, assume rock on top slid off. 2015: Erosion pockets covered with plastic. [2015 Site ID: STR_26-5_L]

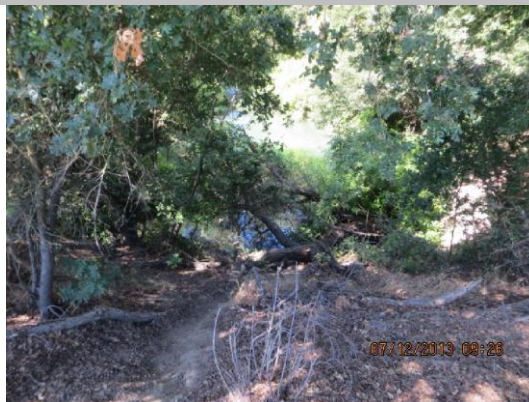
Photo 2 of 2 : UCIP\_SP\_2017\_15708\_26136.jpg

LM Start	0.00	Rating **	A/W	Issue No.	49
LM End	0.00	Issue Type +	Ma	Location *	LS
Category	Supplemental			GPS Latitude/Longitude	
				Start	End
Item	DWR UCIP LMA Responsibility			38.414022 °	38.414022 °
				-121.522986 °	-121.522986 °
DWR ID					
Comment Code					
Inspector Comment					
FS_ID:15708 DS_ID:22788 EP_NO: N/A Repair Type: No Action Needed Crossing Status: Found UCIP Comments: FIELD_STRUCT_DESC: 5'x5' concrete culvert through the levee 30.0 feet below the crown. Slide gate in 6'X8' concrete vault on the waterward shoulder. Originally included in the 1966 O&M manual. FS Date: 7/12/2013

Toe of LS at approximate location of outlet/inlet.

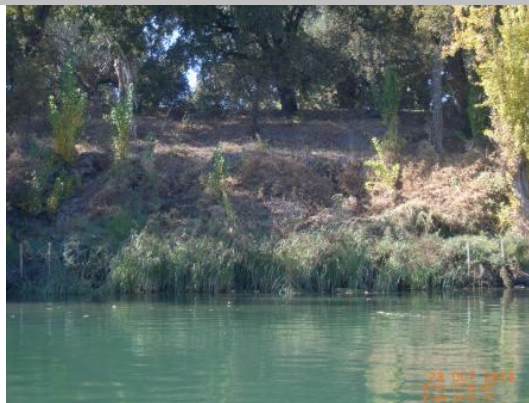
Photo 1 of 1 : SP\_2017\_RD0999\_235\_8\_20170314\_00005.jpg

LM Start	<b>0.02</b>	Rating **	M	Issue No.	<b>8</b>
LM End	<b>0.28</b>	Issue Type +	Ma	Location *	WS
Category	Supplemental		GPS Latitude/Longitude		
			Start	End	
Item	2015 USACE Erosion Survey, DRAFT		38.414387°	38.417692°	
			-121.522871°	-121.525083°	
DWR ID	DWR_RD0999_04_s_2016_8				
Comment Code					
Inspector Comment					
1997 - Structural problem rather than erosional, failed cobble at downstream end. 2005 - New brush boxes at waterline for several hundred feet downstream, No toe or bank protection present. 2006 - Some minor new erosion. Brush boxes not working well; most of the brush has floated out. 2007 - Brush boxes have recently been repaired. 2015: No observed changes. [2015 Site ID: SAC_41-9_R]

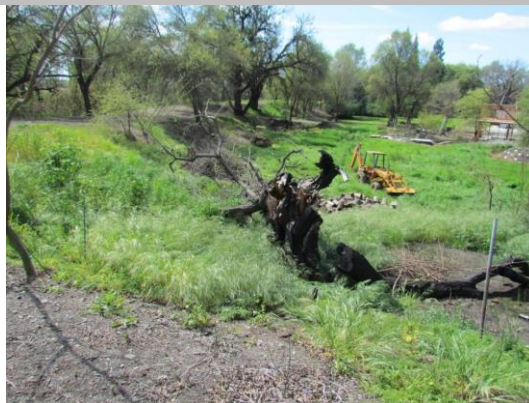
Photo 1 of 1 : SP\_2017\_RD0999\_235\_45\_20170324\_00073.jpg

LM Start	0.03	Rating **	M	Issue No.	45
LM End	0.03	Issue Type +	Ma	Location *	LS
Category	Earthen Levee			GPS Latitude/Longitude	
				Start	End
Item	Encroachments			38.414335 °	38.414335 °
				-121.523348 °	-121.523348 °
DWR ID	DWR_RD0999_04_s_2017_45				
Comment Code					
TR : Tree or limb					
Inspector Comment					
Large downed tree on landward slope.

Looking west at fallen tree on landward slope.

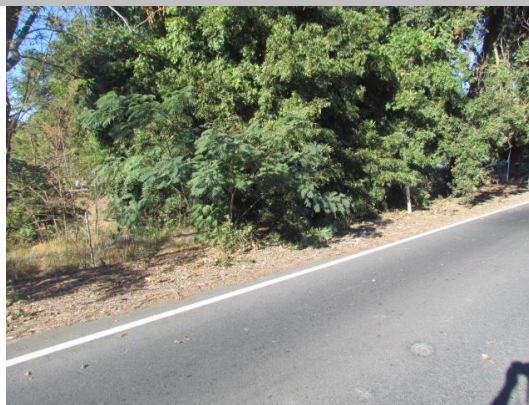
Photo 1 of 1 : SP\_2017\_RD0999\_235\_35\_20170314\_00021.jpg

LM Start	0.03	Rating **	M	Issue No.	35
LM End	0.03	Issue Type +	Ma	Location *	LS
Category	Earthen Levee			GPS Latitude/Longitude	
				Start	End
Item	Trim / Thin Trees			38.414450 °	38.414450 °
				-121.523308 °	-121.523308 °
DWR ID	DWR_RD0999_04_f_2014_35				
Comment Code					
T1 : Trim trees to at least five feet above ground level.					
Inspector Comment					
Untrimmed trees on landward slope and toe.

Looking at untrimmed trees on landward slope.

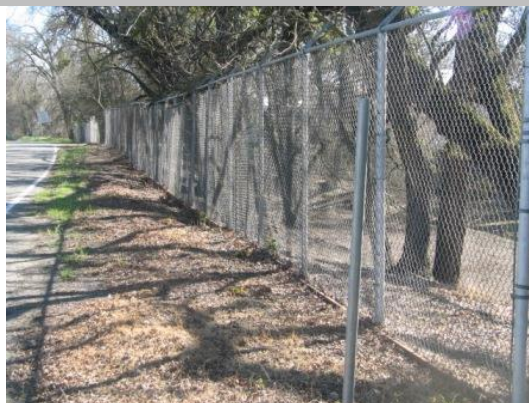
Photo 1 of 1 : SP\_2017\_RD0999\_235\_13\_20170314\_00012.jpg

LM Start	0.05	Rating **	M	Issue No.	13
LM End	0.11	Issue Type +	En	Location *	LS
Category	Earthen Levee			GPS Latitude/Longitude	
				Start	End
Item	Encroachments			38.414672 °	38.415468 °
				-121.523527 °	-121.524037 °
DWR ID	DWR_RD0999_04_s_2012_13				
Comment Code					
FE : Fence					
Inspector Comment

Cyclone fence along landside shoulder at LM 0.05 -0.11

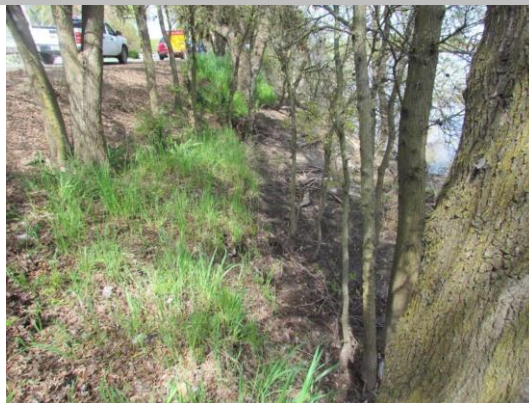
Photo 2 of 2 : SP\_2017\_RD0999\_235\_15\_20170324\_00075.jpg

LM Start	0.11	Rating **	U	Issue No.	15 (cont)	
LM End	0.21	Issue Type +	Ma	Location *	WS	
Category	Earthen Levee			GPS Latitude/Longitude		
				Start		End
Item	Erosion / Bank Caving			38.415425 °		38.416733 °
				-121.523920 °		-121.524705 °
DWR ID	DWR_RD0999_04_s_2017_15					
Comment Code						
E2 : Schedule repair of erosion site prior to the next inspection.						
Inspector Comment						
Waterside erosion 2ft vertical cut.

Looking upstream at 2ft plus vertical erosion on waterward slope.

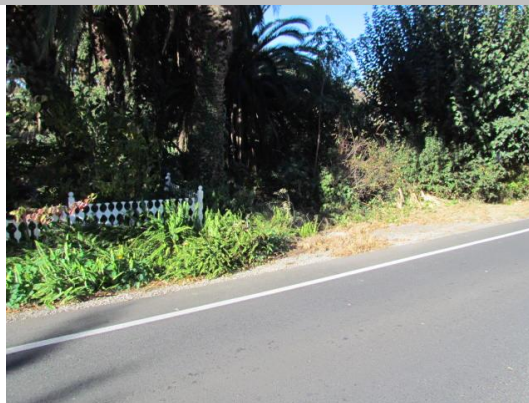
Photo 1 of 2 : SP\_2017\_RD0999\_235\_38\_20170314\_00025.jpg

LM Start	0.16	Rating **	U	Issue No.	38
LM End	0.16	Issue Type +	En	Location *	LS
Category	Earthen Levee			GPS Latitude/Longitude	
				Start	End
Item	Vegetation			38.416040 °	38.416040 °
				-121.524282 °	-121.524282 °
DWR ID	DWR_RD0999_04_f_2015_38				
Comment Code					
V6 : Landscaping					
Inspector Comment					
Dense landscaping on landward slope and toe.

Looking northwest at dense landscaping on landward slope and toe.

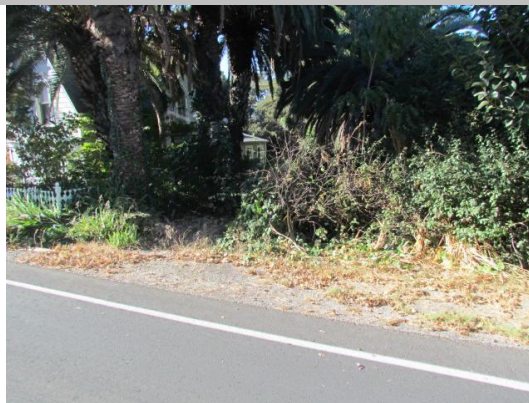
Photo 2 of 2 : SP\_2017\_RD0999\_235\_38\_20170314\_00026.jpg

LM Start	0.16	Rating **	U	Issue No.	38 (cont)	
LM End	0.16	Issue Type +	En	Location *	LS	
Category	Earthen Levee			GPS Latitude/Longitude		
				Start		End
Item	Vegetation			38.416040 °		38.416040 °
				-121.524282 °		-121.524282 °
DWR ID	DWR_RD0999_04_f_2015_38					
Comment Code						
V6 : Landscaping						
Inspector Comment						
Dense landscaping on landward slope and toe.

Looking southwest at dense landscaping on landward slope and toe.

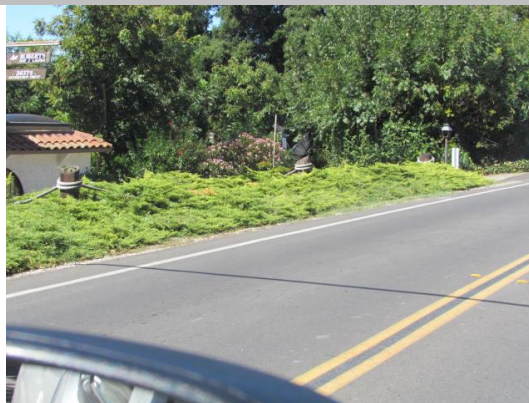
Photo 1 of 1 : SP\_2017\_RD0999\_235\_20\_20170314\_00017.jpg

LM Start	0.28	Rating **	M	Issue No.	20
LM End	0.30	Issue Type +	En	Location *	LS
Category	Earthen Levee			GPS Latitude/Longitude	
				Start	End
Item	Vegetation			38.417600 °	38.417856 °
				-121.525439 °	-121.525613 °
DWR ID	DWR_RD0999_04_f_2013_20				
Comment Code					
V6 : Landscaping					
Inspector Comment

Looking west at dense landscaping on landward slope.

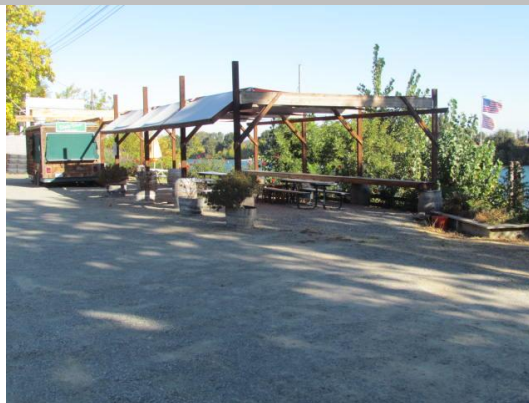
Photo 1 of 3 : SP\_2017\_RD0999\_235\_36\_20170314\_00022.jpg

LM Start	0.29	Rating **	U	Issue No.	36
LM End	0.29	Issue Type +	En	Location *	WS
Category	Earthen Levee			GPS Latitude/Longitude	
				Start	End
Item	Encroachments			38.417809 °	38.417809 °
				-121.525488 °	-121.525488 °
DWR ID	DWR_RD0999_04_f_2014_36				
Comment Code					
BU : Building					
Inspector Comment					
Land owner built patio structure next to mobile dinner on waterward shoulder area without Board permit.

Looking northeast at patio on waterward shoulder.

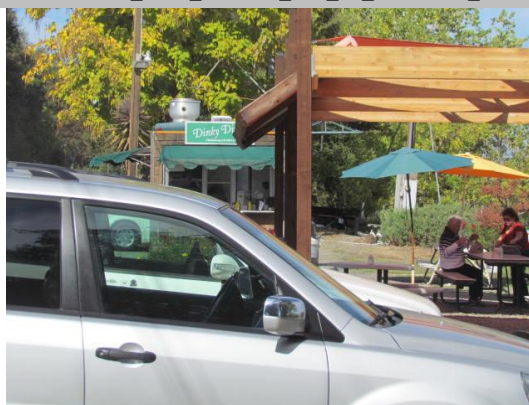
Photo 2 of 3 : SP\_2017\_RD0999\_235\_36\_20170314\_00023.jpg

Looking north at patio structure on waterward shoulder.

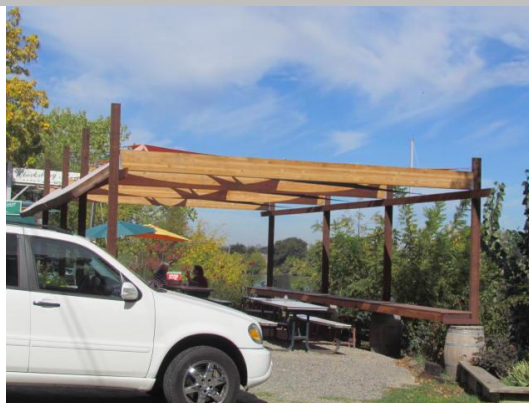
Photo 3 of 3 : SP\_2017\_RD0999\_235\_36\_20170314\_00024.jpg

Looking northeast at patio structure on waterward shoulder.

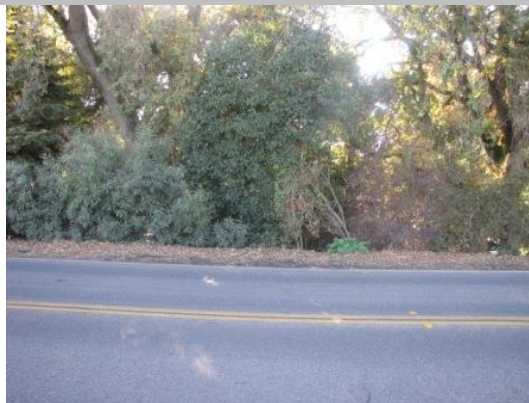
Photo 1 of 2 : SP\_2017\_RD0999\_235\_12\_20170314\_00010.jpg

LM Start	0.31	Rating **	U	Issue No.	12
LM End	0.35	Issue Type +	En	Location *	LS
Category	Earthen Levee			GPS Latitude/Longitude	
				Start	End
Item	Vegetation			38.418002 °	38.418470 °
				-121.525712 °	-121.526002 °
DWR ID	DWR_RD0999_04_s_2012_12				
Comment Code					
V6 : Landscaping					
Inspector Comment

Looking west at dense vegetation on landside slope and toe.

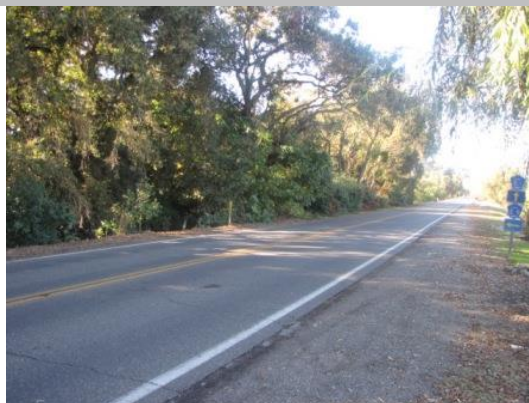
Photo 2 of 2 : SP\_2017\_RD0999\_235\_12\_20170314\_00011.jpg

Looking northwest at dense vegetation on landside shoulder and slope.

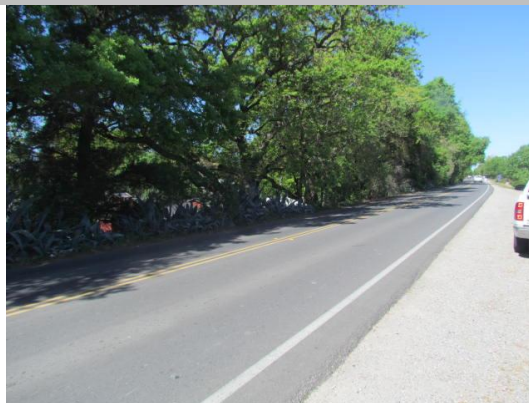
Photo 1 of 2 : SP\_2017\_RD0999\_235\_11\_20170314\_00008.jpg

LM Start	0.38	Rating **	U	Issue No.	11
LM End	0.49	Issue Type +	En	Location *	LS
Category	Earthen Levee			GPS Latitude/Longitude	
				Start	End
Item	Vegetation			38.418838 °	38.420237 °
				-121.526225 °	-121.527193 °
DWR ID	DWR_RD0999_04_s_2012_11				
Comment Code					
V6 : Landscaping					
Inspector Comment

Looking northwest at dense landscaping on landward slope. (Spring 2015)

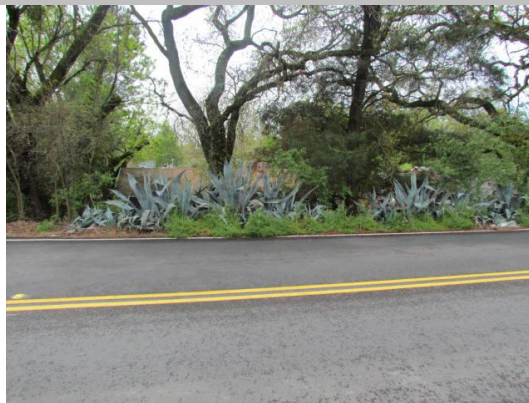
Photo 2 of 2 : SP\_2017\_RD0999\_235\_11\_20170314\_00009.jpg

LM Start	0.38	Rating **	U	Issue No.	11 (cont)	
LM End	0.49	Issue Type +	En	Location *	LS	
Category	Earthen Levee			GPS Latitude/Longitude		
				Start		End
Item	Vegetation			38.418838 °		38.420237 °
				-121.526225 °		-121.527193 °
DWR ID	DWR_RD0999_04_s_2012_11					
Comment Code						
V6 : Landscaping						
Inspector Comment

Looking west at century plants on landside shoulder and slope.

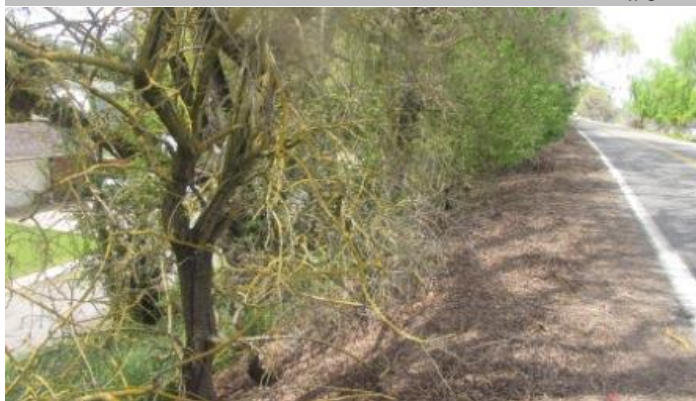
Photo 1 of 2 : SP\_2017\_RD0999\_235\_10\_20170314\_00006.jpg

LM Start	0.38	Rating **	M	Issue No.	10
LM End	0.50	Issue Type +	Ma	Location *	LS
Category	Earthen Levee			GPS Latitude/Longitude	
				Start	End
Item	Trim / Thin Trees			38.418838 °	38.420447 °
				-121.526225 °	-121.527380 °
DWR ID	DWR_RD0999_04_s_2012_10				
Comment Code					
T1 : Trim trees to at least five feet above ground level.					
Inspector Comment

Looking northwest at dense trees on landside slope and toe.

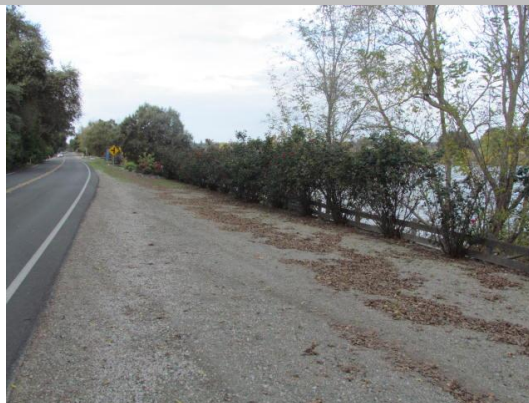
Photo 1 of 1 : SP\_2017\_RD0999\_235\_1\_20170314\_00001.jpg

LM Start	0.40	Rating **	M	Issue No.	1
LM End	0.47	Issue Type +	En	Location *	WS
Category	Earthen Levee			GPS Latitude/Longitude	
				Start	End
Item	Vegetation			38.419137 °	38.420078 °
				-121.526280 °	-121.526913 °
DWR ID	DWR_RD0999_04_s_2012_1				
Comment Code					
V6 : Landscaping					
Inspector Comment

Looking north at rose bushes on waterside slope.

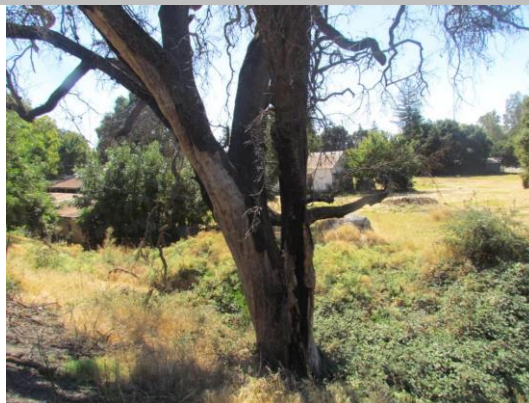
Photo 1 of 2 : SP\_2017\_RD0999\_235\_21\_20170314\_00018.jpg

LM Start	0.58	Rating **	A/W	Issue No.	21
LM End	0.58	Issue Type +	Ma	Location *	LS
Category	Earthen Levee			GPS Latitude/Longitude	
				Start	End
Item	Vegetation			38.421394 °	38.421394 °
				-121.527963 °	-121.527963 °
DWR ID	DWR_RD0999_04_f_2013_21				
Comment Code					
V7 : Trees / Woody Vegetation					
Inspector Comment					
Dead tree on landward slope and toe.

Looking southwest at dead tree at landward toe.

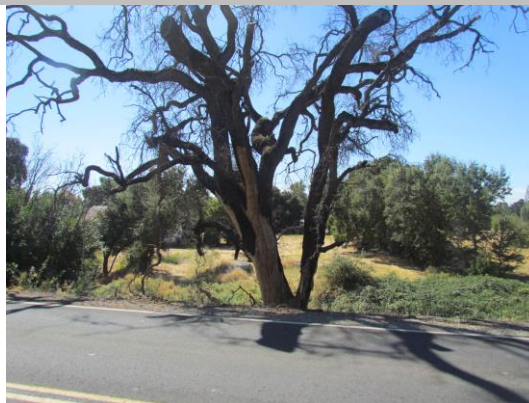
Photo 2 of 2 : SP\_2017\_RD0999\_235\_21\_20170314\_00019.jpg

LM Start	0.58	Rating **	A/W	Issue No.	21 (cont)	
LM End	0.58	Issue Type +	Ma	Location *	LS	
Category	Earthen Levee			GPS Latitude/Longitude		
				Start		End
Item	Vegetation			38.421394 °		38.421394 °
				-121.527963 °		-121.527963 °
DWR ID	DWR_RD0999_04_f_2013_21					
Comment Code						
V7 : Trees / Woody Vegetation						
Inspector Comment						
Dead tree on landward slope and toe.

Looking west at dead tree at landward toe.

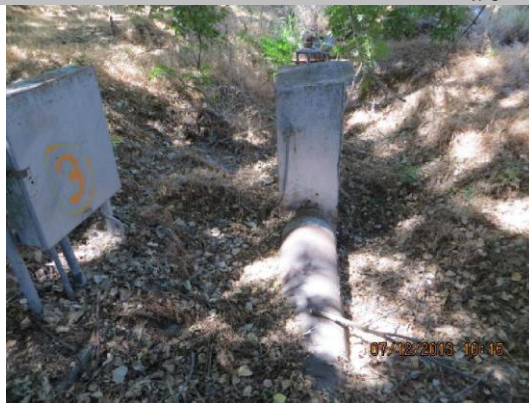
Photo 2 of 3 : UCIP\_SP\_2017\_15712\_26149.jpg

LM Start	0.71	Rating **	M	Issue No.	51 (cont)	
LM End	0.71	Issue Type +	En	Location *	LS	
Category	Supplemental			GPS Latitude/Longitude		
				Start	End	
Item	DWR UCIP Field Study			38.423062 °	38.423062 °	
				-121.529241 °	-121.529241 °	
DWR ID						
Comment Code						
Inspector Comment						
FS_ID:15712						
DS_ID:22791						
EP_NO: 3973						
Repair Type: Non-Urgent						
Crossing Status: Found						
UCIP Comments: Slide gate broken on LS toe. Appears it may be abandoned.						
FIELD_STRUCT_DESC: 18-inch steel stormdrain pipe through the levee 4.7 feet below the crown. air vent in 18-inch steel standpipe on the waterward shoulder. Gate valve on the land side toe (Permit No. 3973, 1962). Originally included in the 1966 O&M manual.						
FS Date: 7/12/2013

Electrical panel, water meter, and gate valve on LS toe.

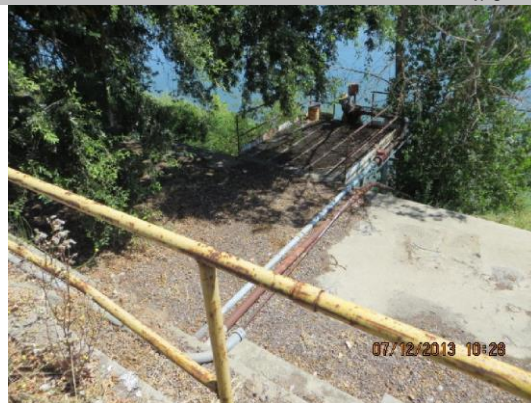
Photo 1 of 3 : UCIP\_SP\_2017\_15725\_26181.jpg

LM Start	0.74	Rating **	M	Issue No.	52
LM End	0.74	Issue Type +	En	Location *	LS
Category	Supplemental			GPS Latitude/Longitude	
				Start	End
Item	DWR UCIP Field Study			38.423418 °	38.423418 °
				-121.529486 °	-121.529486 °
DWR ID					
Comment Code					
Inspector Comment					
FS_ID:15725 DS_ID:22796 EP_NO: 10514 Repair Type: Non-Urgent Crossing Status: Found UCIP Comments: Pipe appears abandoned and should be done so properly. FIELD_STRUCT_DESC: 1 of 3: 3.5-inch discharge pipe through the levee 3.8 feet below the crown. Siphon breaker at headwall on the waterward slope. (Permit No. 10514, 1974) FS Date: 7/12/2013

Discharge pipe at concrete pad then down slope to water.

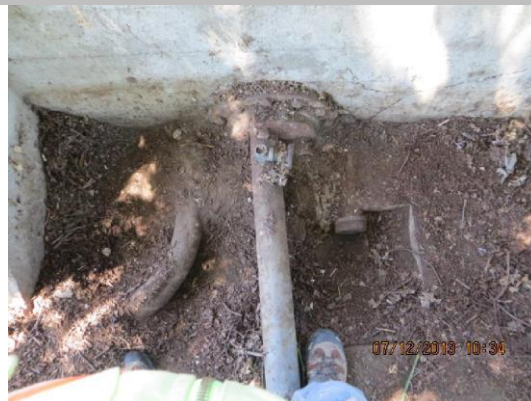
Photo 2 of 3 : UCIP\_SP\_2017\_15725\_26180.jpg

Siphon breaker at headwall on WS.

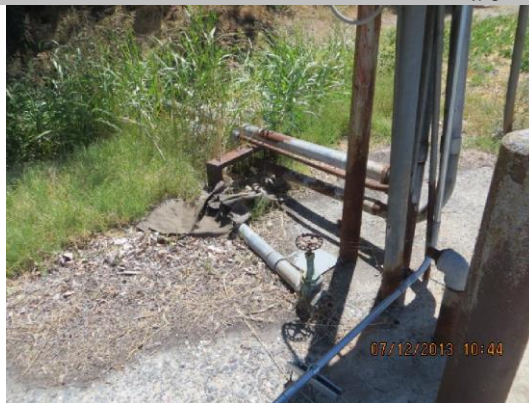
Photo 3 of 3 : UCIP\_SP\_2017\_15725\_26179.jpg

LM Start	0.74	Rating **	M	Issue No.	52 (cont)	
LM End	0.74	Issue Type +	En	Location *	LS	
Category	Supplemental			GPS Latitude/Longitude		
				Start	End	
Item	DWR UCIP Field Study			38.423418 °	38.423418 °	
				-121.529486 °	-121.529486 °	
DWR ID						
Comment Code						
Inspector Comment						
FS_ID:15725						
DS_ID:22796						
EP_NO: 10514						
Repair Type: Non-Urgent						
Crossing Status: Found						
UCIP Comments: Pipe appears abandoned and should be done so properly.						
FIELD_STRUCT_DESC: 1 of 3: 3.5-inch discharge pipe through the levee 3.8 feet below the crown. Siphon breaker at headwall on the waterward slope. (Permit No. 10514, 1974)						
FS Date: 7/12/2013

Pipe with gate valve off LS toe.

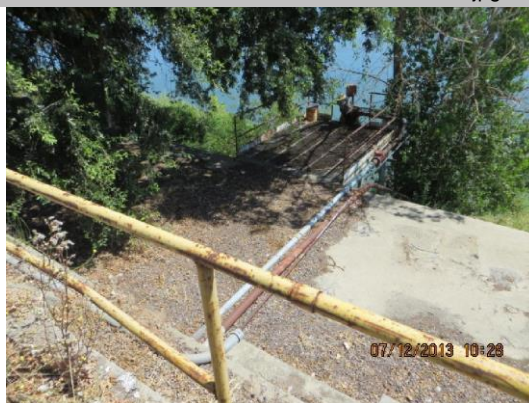
Photo 1 of 3 : UCIP\_SP\_2017\_41556\_26160.jpg

LM Start	0.74	Rating **	M	Issue No.	53
LM End	0.74	Issue Type +	En	Location *	LS
Category	Supplemental			GPS Latitude/Longitude	
				Start	End
Item	DWR UCIP Field Study			38.423429 °	38.423429 °
				-121.529491 °	-121.529491 °
DWR ID					
Comment Code					
Inspector Comment					
FS_ID:41556 DS_ID:22794 EP_NO: N/A Repair Type: Non-Urgent Crossing Status: Found UCIP Comments: Good candidate for video inspection. FIELD_STRUCT_DESC: 10-inch steel conduit through the levee 3.8 feet below the crown. 4.5-inch galvanized iron pipe sleeved through conduit with annular space grouted. Originally included in the 1966 O&M manual. FS Date: 7/12/2013

Pump on pier for 4.5-inch pipe sleeved through 10-inch.

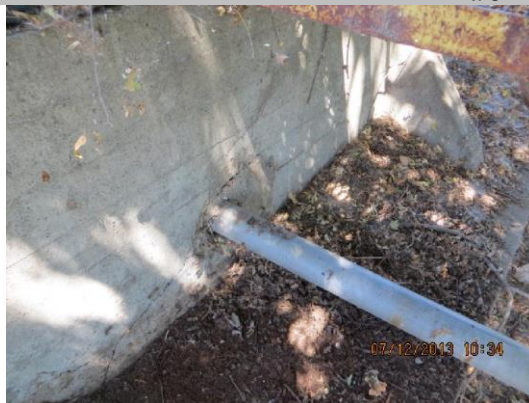
Photo 2 of 3 : UCIP\_SP\_2017\_41556\_26159.jpg

LM Start	0.74	Rating **	M	Issue No.	53 (cont)	
LM End	0.74	Issue Type +	En	Location *	LS	
Category	Supplemental			GPS Latitude/Longitude		
				Start	End	
Item	DWR UCIP Field Study			38.423429 °	38.423429 °	
				-121.529491 °	-121.529491 °	
DWR ID						
Comment Code						
Inspector Comment						
FS_ID:41556						
DS_ID:22794						
EP_NO: N/A						
Repair Type: Non-Urgent						
Crossing Status: Found						
UCIP Comments: Good candidate for video inspection.						
FIELD_STRUCT_DESC: 10-inch steel conduit through the levee 3.8 feet below the crown. 4.5-inch galvanized iron pipe sleeved through conduit with annular space grouted. Originally included in the 1966 O&M manual.						
FS Date: 7/12/2013

4.5-inch pipe at headwall on WS slope.

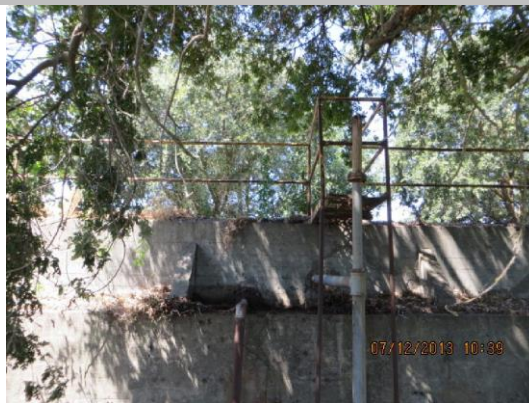
Photo 3 of 3 : UCIP\_SP\_2017\_41556\_26158.jpg

4.5-inch pipe at headwall on WS slope.

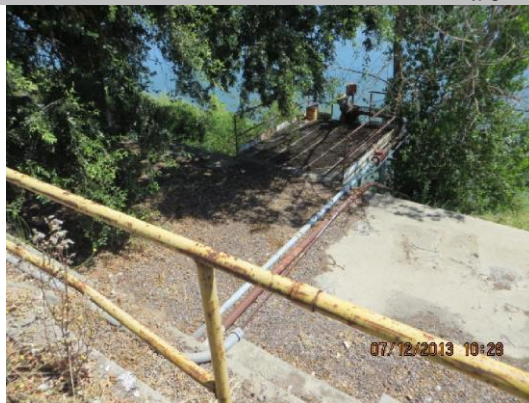
Photo 1 of 2 : UCIP\_SP\_2017\_41535\_26167.jpg

LM Start	0.74	Rating **	M	Issue No.	54
LM End	0.74	Issue Type +	En	Location *	LS
Category	Supplemental			GPS Latitude/Longitude	
				Start	End
Item	DWR UCIP Field Study			38.423418 °	38.423418 °
				-121.529486 °	-121.529486 °
DWR ID					
Comment Code					
Inspector Comment					
FS_ID:41535					
DS_ID:22795					
EP_NO: N/A					
Repair Type: Non-Urgent					
Crossing Status: Found					
UCIP Comments: Pipes appear abandoned and should be checked usage or abandoned properly.					
FIELD_STRUCT_DESC: 3.5-inch galvanized iron electrical conduit through the levee 3.8-feet below the crown. Concrete headwall and pad on WS slope. Pipe open on WS.					
FS Date: 7/12/2013

Electrical conduit shown at bottom of picture (pipe with 90-degree bend).

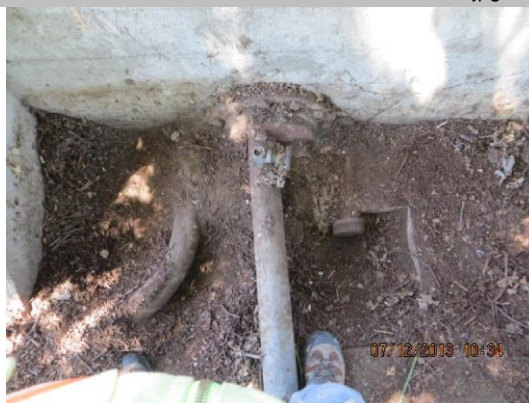
Photo 2 of 2 : UCIP\_SP\_2017\_41535\_26166.jpg

3.5-inch electrical conduit shown at left of 10-inch pipe.

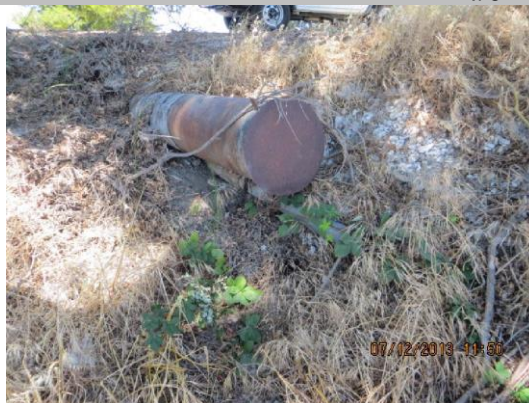
Photo 1 of 2 : UCIP\_SP\_2017\_16389\_27669.jpg

LM Start	0.82	Rating **	M	Issue No.	56
LM End	0.82	Issue Type +	En	Location *	LS
Category	Supplemental			GPS Latitude/Longitude	
				Start	End
Item	DWR UCIP Field Study			38.424399 °	38.424399 °
				-121.530178 °	-121.530178 °
DWR ID					
Comment Code					
Inspector Comment					
FS_ID:16389 DS_ID:22797 EP_NO: 1624 Repair Type: Non-Urgent Crossing Status: Found UCIP Comments: Pipe abandoned and should be done so properly. FIELD_STRUCT_DESC: 16-inch steel irrigation pipe through the levee 3.0 feet below the crown. Pump and pile structure removed from waterside toe. Steel plate welded over WS end (Permit No. 1624, 1959). Replaces an existing facility north of this location. FS Date: 7/12/2013

Pipe with steel plate welded over WS end.

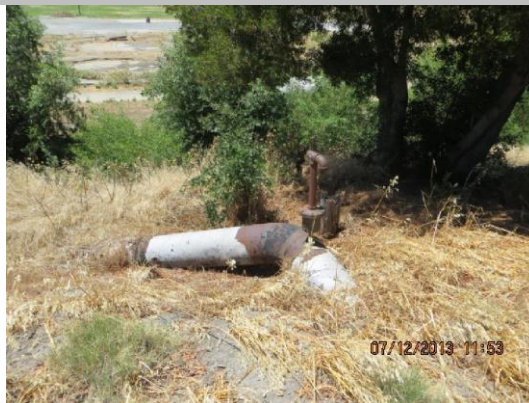
Photo 2 of 2 : UCIP\_SP\_2017\_16389\_27668.jpg

Pipe and vent/siphon breaker on LS slope.

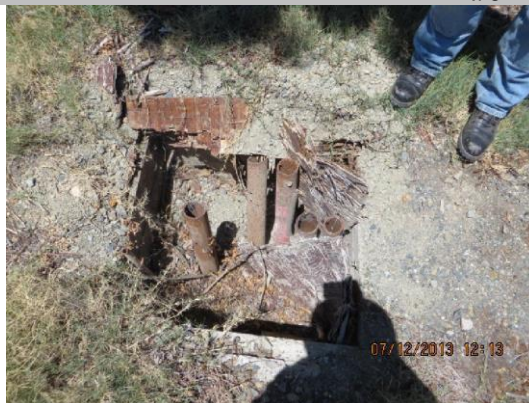
Photo 1 of 3 : UCIP\_SP\_2017\_16385\_27655.jpg

LM Start	0.90	Rating **	M	Issue No.	57
LM End	0.90	Issue Type +	En	Location *	LS
Category	Supplemental			GPS Latitude/Longitude	
				Start	End
Item	DWR UCIP Field Study			38.425514 °	38.425514 °
				-121.530970 °	-121.530970 °
DWR ID					
Comment Code					
Inspector Comment					
FS_ID:16385 DS_ID:22809 EP_NO: N/A Repair Type: Non-Urgent Crossing Status: Found UCIP Comments: Pipe abandoned and should be done so properly. FIELD_STRUCT_DESC: *ABANDONED* 5 of 6: 3.5-inch pipe through levee 2.5 feet below crown. Visible in concrete well on LS shoulder. FS Date: 7/12/2013

Pipe in concrete vault on LS shoulder.

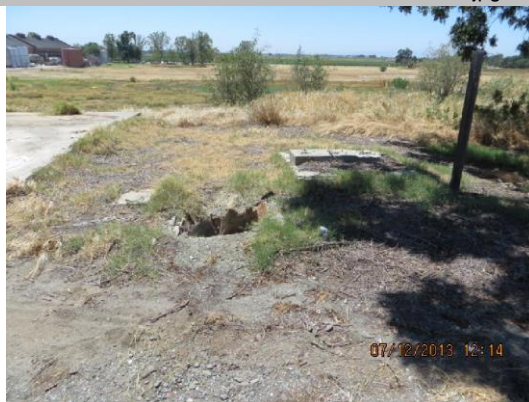
Photo 2 of 3 : UCIP\_SP\_2017\_16385\_27654.jpg

LM Start	<b>0.90</b>	Rating **	M	Issue No.	<b>57 (cont)</b>
LM End	<b>0.90</b>	Issue Type +	En	Location *	LS

Pipe in concrete vault on LS shoulder.

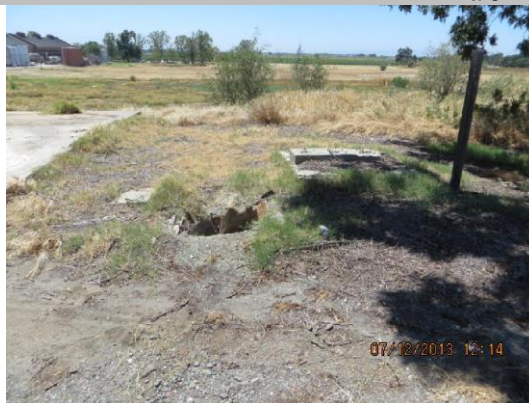
Photo 2 of 3 : UCIP\_SP\_2017\_16386\_27660.jpg

LM Start	0.90	Rating **	M	Issue No.	58 (cont)	
LM End	0.90	Issue Type +	En	Location *	LS	
Category	Supplemental			GPS Latitude/Longitude		
				Start		End
Item	DWR UCIP Field Study			38.425514 °		38.425514 °
				-121.530970 °		-121.530970 °
DWR ID						
Comment Code						
Inspector Comment						
FS_ID:16386 DS_ID:22810 EP_NO: N/A Repair Type: Non-Urgent Crossing Status: Found UCIP Comments: Pipe abandoned and should be done so properly. FIELD_STRUCT_DESC: *ABANDONED* 6 of 6: 3.5-inch pipe through levee 2.5 feet below crown. Pipe visible in concrete well on LS shoulder. FS Date: 7/12/2013

Pipes visible in concrete well on LS shoulder.

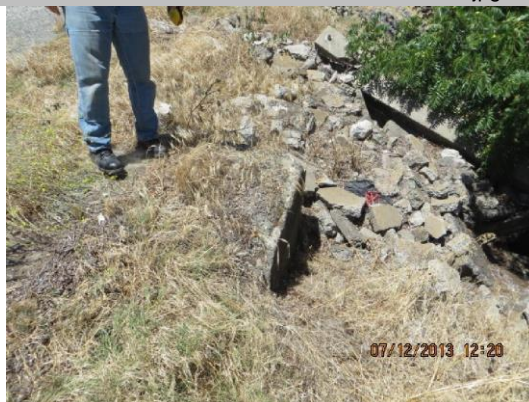
Photo 3 of 3 : UCIP\_SP\_2017\_16386\_27659.jpg

Assumed pipes are visible in concrete well on WS shoulder. Soil covers lid on concrete well.
